■ Appendices

Appendix A—Injuries

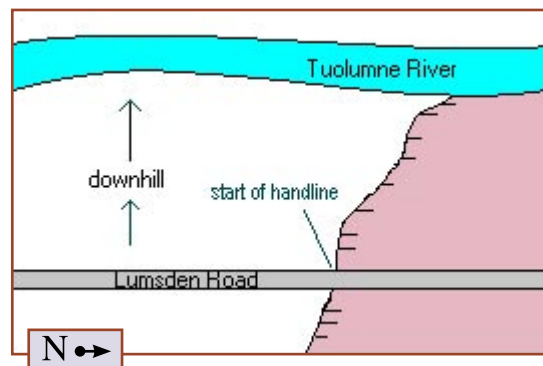
Upon arrival of the initial attack resources, the fire was backing down-canyon (toward the southwest) against an up-canyon wind. Flame lengths were described as less than 1 foot by the Incident Commander (IC) who drove to the right flank a few minutes before Helitack Crew 404 reached the line. Upon arrival, Helitack Captain (HC) Winger checked the lower right flank below Lumsden Road. The fire contoured down-slope but bent up-canyon toward the northeast. The fire below the road was aligned fairly closely with its extension above the road. The fire was creeping slowly down-canyon.

Figure 1: Fire alignment at time of initial ground attack. Pink area represents burn.
